Manhole Inspection Summary

Manhole # S49II_044MH

Insp Date: **5/14/08 8:20 AM**

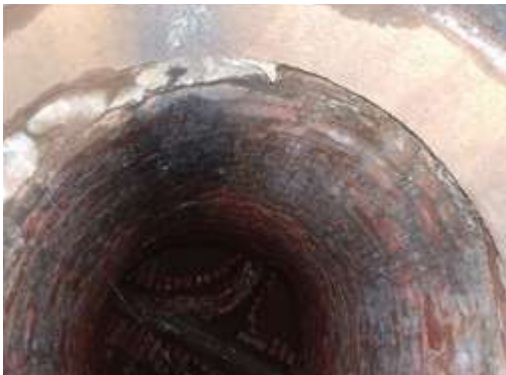
Defect 1

Infiltration

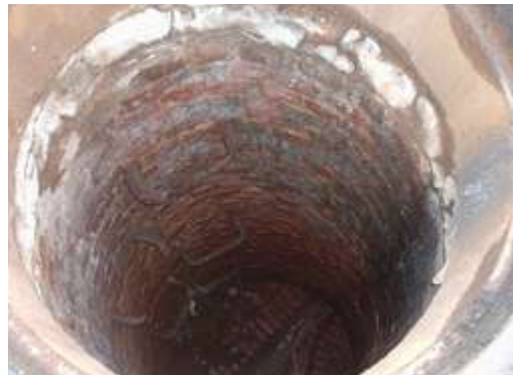
Defect 2

frame leaks

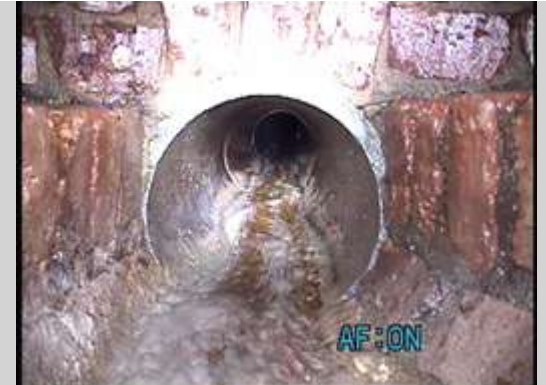
12 O'Clock Outflow

8 in. Circular Gravity Sewer
Pipe Out @ 12 O'Clock

Pipe Height: **8.4** (in.) Rod and Bar (Angled)
Pipe Material: **Clay** ☐ Pipe Lined
Invert Depth: **12.75** (ft.) Flow Characteristics: **Fast**
Deposits: ☒ None ☐ Mud ☐ Sludge ☐ Debris ☐ Grease
Silt Depth: (in.) Deposits Extent:
Infiltration: **None** Pipe Seal Cond: **Sound**

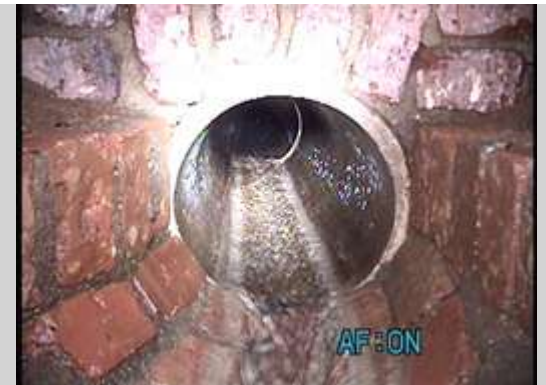
3 O'Clock Inflow

8 in. Circular Gravity Sewer
Pipe In @ 3 O'Clock

Pipe Height: **8.4** (in.) Rod and Bar (Angled)
Pipe Material: **Clay** ☐ Pipe Lined
Invert Depth: **12.60** (ft.) Flow Characteristics: **Fast**
Deposits: ☒ None ☐ Mud ☐ Sludge ☐ Debris ☐ Grease
Silt Depth: (in.) Deposits Extent:
Infiltration: **None** Pipe Seal Cond: **Sound**

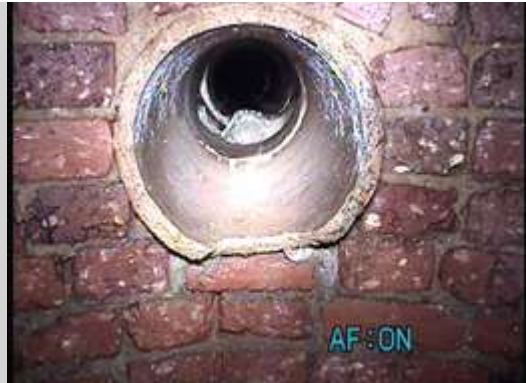
6 O'Clock Inflow

Pipe In @ 6 O'Clock

Infiltration: **None** Pipe Seal Cond: **Sound**

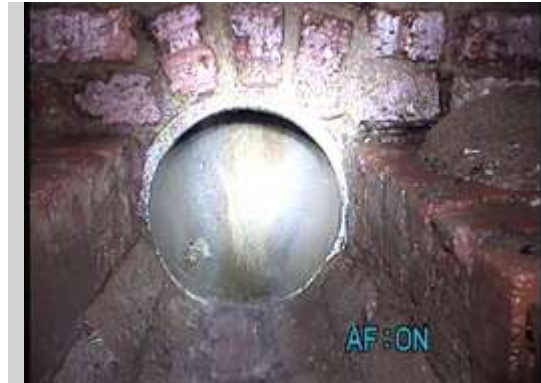
Drop In @ 6 O'Clock

Drop: **Inside**

Drop Condition: **Open**
